Scanning Electron Microscopy and Energy-dispersive X-ray Spectroscopy in Determining the Metallic-shine-loss Causes of a Low Gold Content Conventional Alloy

The aim of this study is to determine the causes which lead to a significant colour change and loss of the metallic shine of a 4-element bridge made of a low-gold-content conventional alloy, only a few months after cementation. The authors used scanning electron microscopy (SEM) with retrodiffused electrons and energy-dispersive X-ray spectroscopy (EDX), applied to the restoration surface and in transversal section.

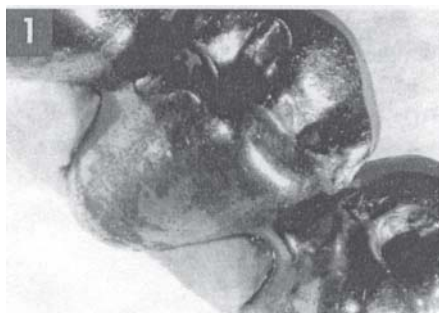
A 4-element bridge (fig. 1) presented a significant colour change and the loss of the metallic shine, only a few months after cementation. It presented darkened and shiny areas. The 4-elements bridge (23-26), made of a low-gold-content conventional class E alloy (Au, Ag, Pd, Cu, Zn), was removed and analyzed in order to determine the causes of this failure.

Fig. 1. The 4-element bridge is characterized by coloration and loss of surface shine

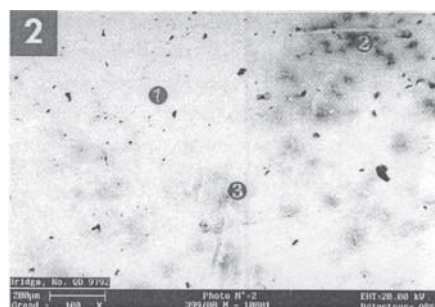
The surface analysis performed with retrodiffused electrons (fig. 2) and energy-dispersive X-ray spectroscopy (EDX) (fig. 3, 4), shows that the coloration is associated with a non-homogeneous surface composition. It shows areas rich in copper and sulfur (area 2, fig. 4), areas rich in silver and sulfur (area 3, fig. 5) and areas without sulfur (area 1, fig. 3).

Fig. 2. Retrodiffused-electron image (chemical contrast) of the 25 crown surface

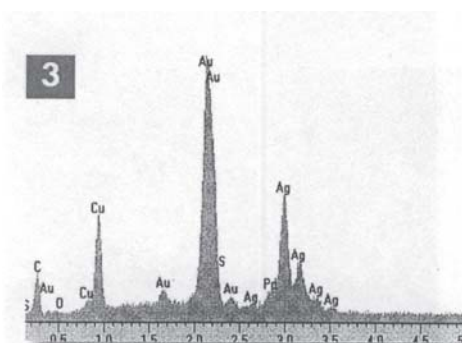
Fig. 3. EDX spectrum of area 1 (area without sulfur)

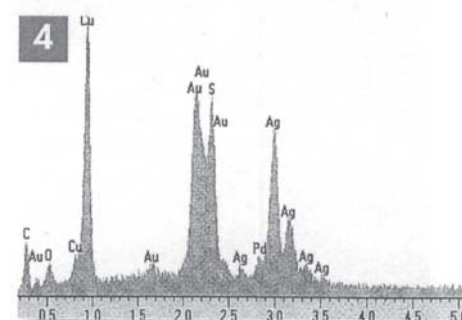
Fig. 4. EDX spectrum of area 2 (area rich in copper and sulfur)

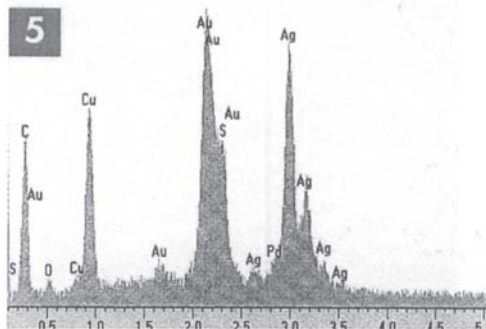
Fig. 5. EDX spectrum of area 3 (area rich in silver and sulfur)

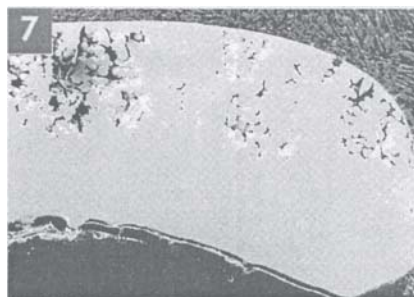
Fig. 7. Section observation with secondary electrons (topographic contrast) SEM analysis with retrodiffused electrons (fig. 8) shows a dendritic non-homogeneous structure, close to the surface.

SEM section analysis using secondary electrons (fig. 7) shows a very important millimetric internal porosity, localised on the external parts and merging at the surface, in some areas.

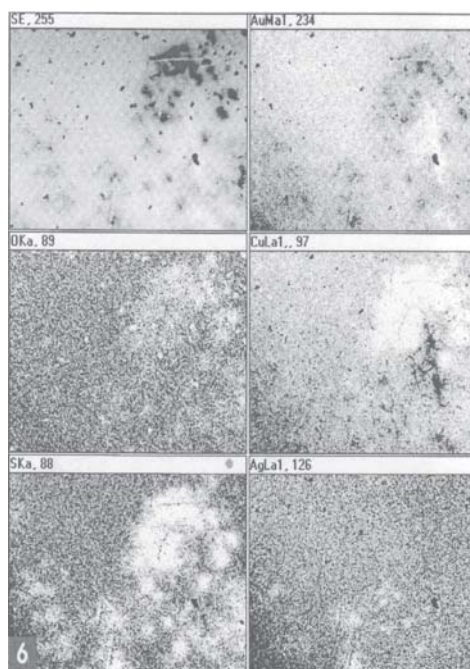
Fig. 6. Retrodiffused electron analysis (chemical contrast) and allocation of the elements (Au, O, Cu, S and Ag)

Retrodiffused electron observation and the location of the elements (Au, O, Cu, S and Ag) (fig. 6) indicated that the shine loss area 2 was characterized by excess of sulfur and copper. The presence of oxygen was associated with copper localization.

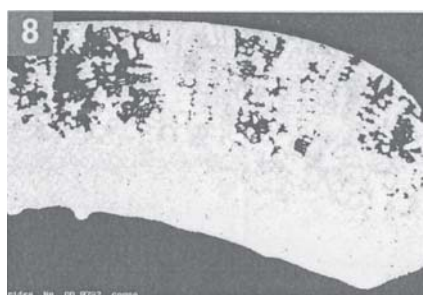
Fig. 8. Section observation with retrodiffused electrons (chemical contrast)

SEM analysis with retrodiffused electrons (fig. 8) shows a dendritic non-homogeneous structure, close to the surface.

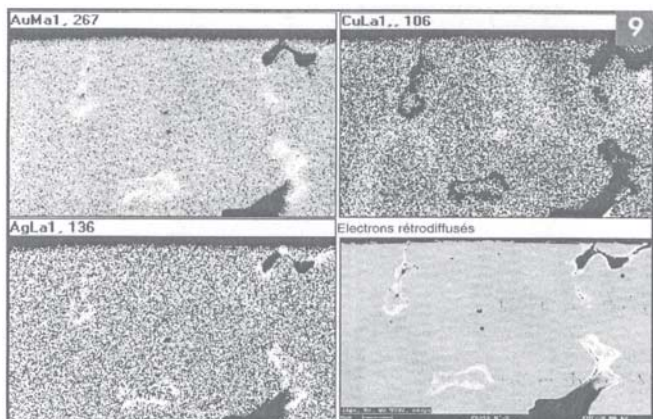
The allocation of the main alloy elements (Au, Ag, Cu), close to the surface, is not homogeneous, mainly in the proximity of the porosity areas. This non-homogeneity is more important in the sub-superficial darkened areas than in the sub-superficial shiny areas. Independent from the porosities coloured in black (fig. 9) we observe, in the darkened sub-superficial area, the presence of the inclusions rich in Au and Ag and poor in Cu. In the shiny sub-superficial areas we observe, in addition to the internal porosities, tiny inclusions very rich in Cu. (fig. 10).

Fig. 9. Observation of the sub-superficial layer of the dark area with retrodiffused electrons (chemical contrast) and element allocation (Au, Ag and Cu)

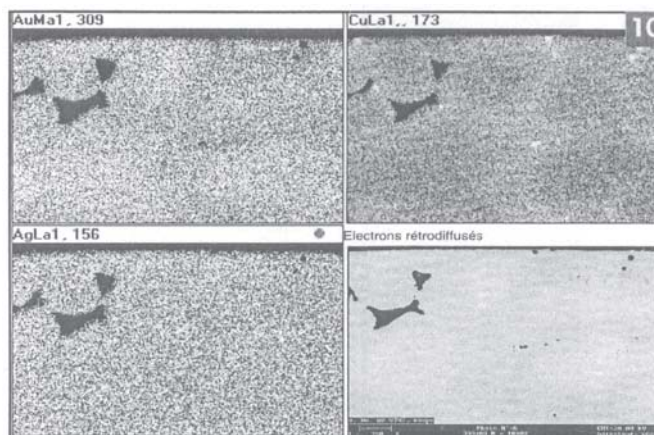
Fig. 10. Observation of the sub-superficial layer of the shiny area with retrodiffused electrons (chemical contrast) and the elements allocation (Au, Ag and Cu)
