# Detecting the Implant *in vitro* Microleakage Using Spectrophotometry and Neutral Red Dye

*Implants are one of the most innovative and less invasive prosthetic procedures available. Almost all types of edentations can, nowadays, be treated with an implant-retained prosthetic piece, either fixed or removable. But regardless of the development in the industry over the last decades and the high success rate - estimated at over 95% - there are still some problems concerning single or multi-unit restorations [1-3]. One of the main concerns about implant therapy today is the microleakage phenomenon. The microleakage appears between the implant and the abutment and, due to masticatory forces, it creates a pump effect which can carry the oral bacteria inside the implant, where it's almost impossible to reach, thus, creating a local inflammation, called peri-implantitis [4-6]. Many authors have tried to identify and quantify the phenomenon by diverse means, but a consensus hasn't been reached on how or when exactly it appears. In the present study, Neutral Red dye was used to determine the sealing of the implant-abutment interface in dynamic conditions, with the help of the spectrophotom

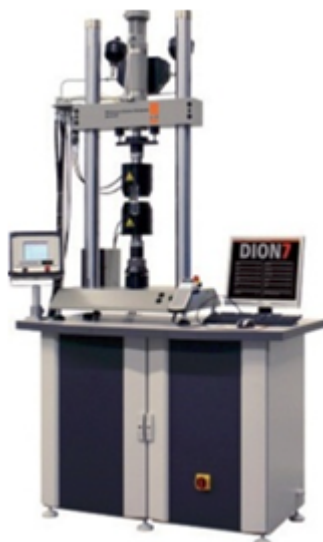
Fig. 3. Walter+bai servo-hydraulic testing machine

The sample holder, with the implant-abutment complex inside of it, was set in the testing machine, in order to start the dynamic load of the abutment. The tests were carried out in the Strength of Materials Laboratory from Politehnica University Timisoara, on a Walter+bai servo-hydraulic testing machine. The characteristics of the Walter+bai testing machine are as follows: dynamic load in tensile/compression  $\pm 8$  kN, accuracy class 0.5 (according to ISO 7500-1 and EN 10002-2), piston stroke  $\pm 50$  mm (fig. 3).

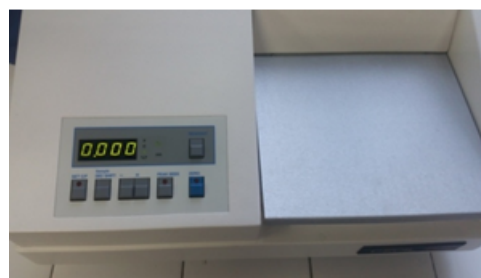
Fig. 5. Cecil Spectrophotometer

To check whether the implant-abutment interface allows the diffusion of the dye, a Cecil CE 1021 UV/Visible spectrophotometer (Cecil Instruments, UK) was used, at a wavelength of 450 nm (Sousa et al., 1996)[15]. To calibrate the spectrophotometer for concentration measurements, a standard solution was prepared of  $0.5 \times 10^{-3}$  % w/v Neutral Red dissolved in distilled water. (fig. 5).
