Corrosion Behaviour of Tin Bronze for Shipbuilding Industry

Bronzes are part of the moving elements of the shipbuilding industry, such as ship propellers, fixtures, flanges, pumps and turbine blades, working both in salt water and in freshwater. In this context, the study regarding shipbuilding elements corrosion in seawater has great importance. The paper includes a chemical and structural analysis of the bronze parts subject to corrosion, using a PGP 201 VoltaLab facility. The cyclic polarization curve was determined. Microstructural analysis was carried out on a tin bronze using scanning electron microscope (SEM) equipped with EDX. Samples were immersed for 40 days in seawater. After that, it was analyzed with optic microscope and by EDX spectroscopy.

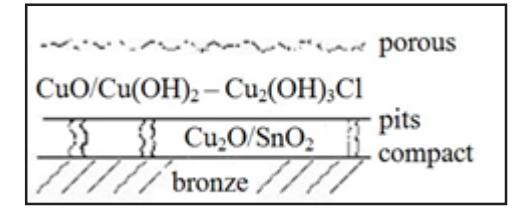
Fig. 1. Qualitative model for the film formed on bronze after exposure to seawaters [29]

Under normal atmospheric temperature and pressure the bronze forms on the surface a protective layer of passive chemical combinations of oxides and sulphides. This layer is attacked while the piece is merged in sea water (especially the Black Sea water with high salinity). In chemically aggressive media the pitting type corrosion can occur, being destructive (film passivity is destroyed locally). In marine conditions, can occur as a result of corrosion, atacamite type compounds ($Cu_2(OH)_3Cl$) or copper sulphate which can partially fill the pores but unevenly, resulting mass transfer by corrosion [25-28]. In figure 1 is shown a corrosion model [20].

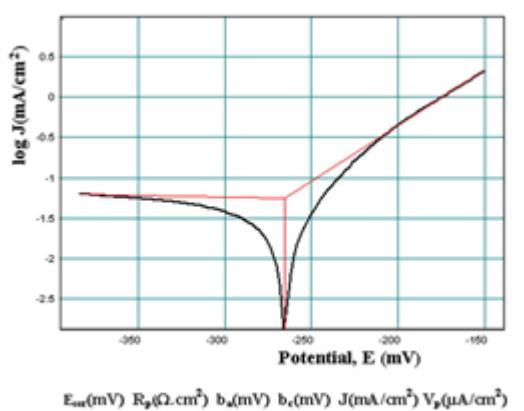
Fig. 3. Evans diagram for the bronze sample in the Black Sea water

The linear polarization curves are shown in figure 3 using semi-logarithmic coordinates (Evans diagram) for the sample corroded in the naturally aerated Black Sea seawater.

The parameters calculated based on these diagrams are shown in the figure basement and highlights the following:

- the corrosion potential, even though it is negative, it is shifted to more positive values than those found for the shape memory alloys, indicating a good corrosion resistance of this alloy;

- the cathodic process is controlled by diffusion; the cathodic sector slope from the polarization curve is steeper than the anode sector slope. Due to the diffusion process, despite the fact that the polarization resistance has a very small value the corrosion rates are 3...4 times smaller than the instantaneously corrosion for the shape memory alloys, which were previously studied in the same conditions [22, 28].

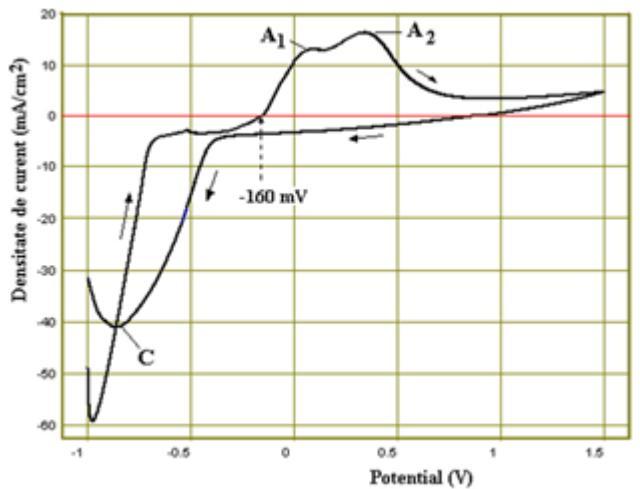
Fig. 4. Electric potential voltammograms diagram for the bronze sample in the naturally aerated Black Sea water

Cyclic polarization curves (fig. 4) recorded from a higher potential range can give additional information about the processes occurring into the system.

In the present study cyclicpotential diagrams (voltammograms) were recorded on the potential range (-1000... +1500... -1000) mV/ESC with a potential scan rate of 5 mV/s. Natural aeration was used to approach as much

- on the anodic sector two distinct maximal values are identified (A1 and A2), and on the (cathodic sector) just one single negative peak is identified (C). At the end of the anaodic sector, close to the 1V/ESC potential, can be observed a pronounced negative peak, which can be associated to the advanced electrochemical surface cleaning. After the anodic peaks, an almost horizontal plateau follows, corresponding to the surface passivation state;

- anodic peak A₁ is associated with the successive formation of the Cu₂O, CuO and Cu(OH)₂ compounds, the quantitative ratio between them, leads to both peak position and the current density value:

- the second anodic peak (A2) can be associated with the transformation CuCl in CuO – according to the following reaction:

- on the cathodic sector, unlike the shape memory alloys, one single peak appears (C), which is associated with the Cu⁺ and Cu²⁺ reduction to metallic copper, regardless of the solid compound in the double layer formed during anodic processes.

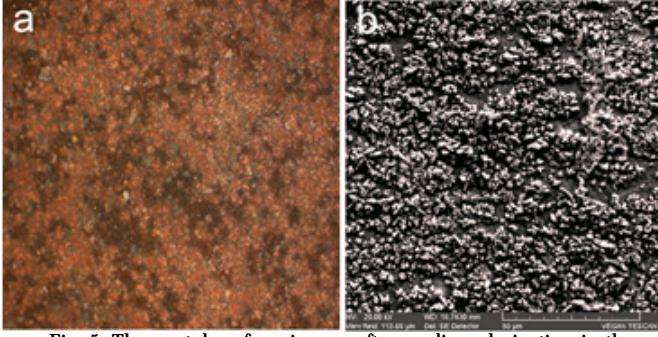
Fig. 5. The metal surface image after cyclic polarization in the Black Sea water:(a) optical microscopy, (b) electronic microscopy

Metallic copper crystallized by reducing copper oxides and hydroxides, it can be seen both in the optical photomicrographs of the surface and in the SEM micrograph (fig. 5).

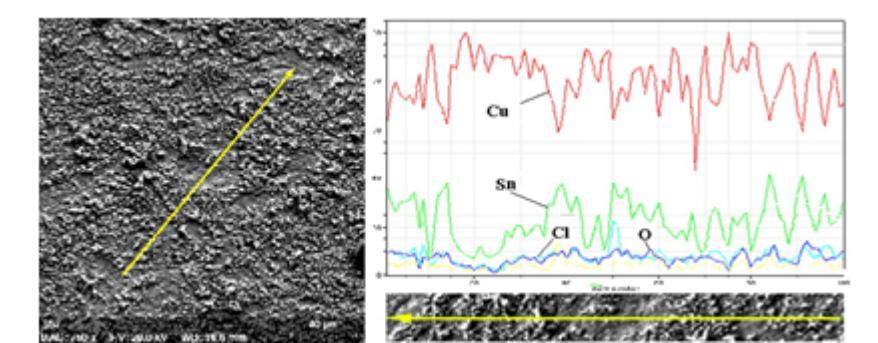
Fig. 6. EDX line scan on the bronze sample surface after cyclic polarization in the Black Sea water

The EDX microanalysis confirms the composition of the surface layer. An EDX line scan is shown in figure 6.

Analyzing the diagram it can be seen that Cl correlates with Sn, suggesting the presence of a compound Sn-Cl. Detailed studies of some copper alloy were made in two doctoral theses [27-29].

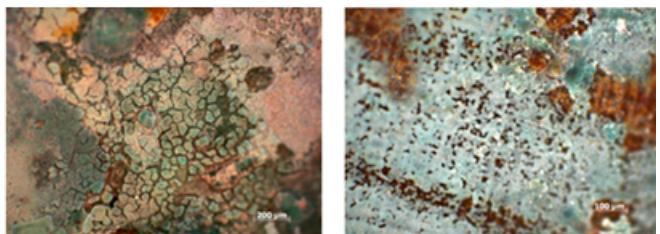
Fig. 7. Dark field optical micrographs of the sample kept 40 days in seawater: left - at 50X, right - at 100X.

The sample was immersed in a sealed tank containing water from the Black Sea. After 40 days the sample was removed from the solution, rinsed with distilled water, dried in air and the surface was examined under the optical microscope (Zeiss Axio Imager A1m). Images were analyzed both dark field (fig. 7) - which allows observation of the true natural colors of corrosion products, but also in bright field (fig. 8), which provides more details on the microstructure but the colors are altered due to the reflected rays reaching the observer. Visual examination of the sample surface after exposure to seawater shows a heterogeneous surface coated with blue-green compounds (fig. 8). It is obvious the occurrence of the corrosion products, but their nature can not be identified from these figures.

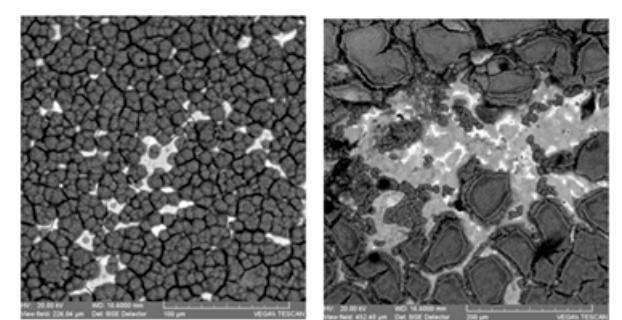
Fig. 8. SEM images of the sample kept 40 days in seawater: left - at 500X, right - at 1000X

The qualitative information on the elements present on the surface was obtained from the EDX spectrums and revealed the presence of Cu, Sn, Al, S, Cl and O. In both cases the essential components are copper and oxygen, and tin, chlorine, sulfur and aluminum are present in a very small amount. It may be assumed that the prevailing

surface is civered with cuprous oxides and copper basic chloride, and the signal for the tin oxide is approximately the same as in the original alloy. It is likely that the absorbed aluminum comes from the seawater [27].
